ILLINOIS ENVIRONMENTAL PROTECTION AGENCY

Livestock Facility Inspection Checklist

FACILITY NAME (LLC, Inc., Corp, Partnership, sole proprietorship, etc.)**FAY-BLA-MAR, Inc****INSPECTION DATE****04-26-11****ARRIVAL TIME****12:50PM****ADDRESS****6740 State Rt. 153****INSPECTOR(S)****BER****DEPARTURE TIME****3:15PM****CITY****Oakdale****STATE****IL****ZIP CODE****62268****ACCOMPANIED BY (if applicable)****JDS/BDR****LEGAL DESCRIPTION****COUNTY****Washington****SECTION****36****TOWNSHIP****2S****RANGE****5W****TEMPERATURE****71 F****PRECIPITATION TYPE****2.6 last 24 hours****Facility Owner(s):**Exemption 6 and Exemption 7C**NAME****Blake Helbig****CONTACTED**☒ YES ☐ NO**PHONE**Exemption 6 and Exemption 7C**MOBILE**Exemption 6 and Exemption 7C**ADDRESS****CITY****STATE****ZIP CODE****NAME****Marvin helbig****CONTACTED**☒ YES ☐ NO**PHONE**Exemption 6 and Exemption 7C**MOBILE**Exemption 6 and Exemption 7C**ADDRESS****6740 State Rt 153****CITY****Oakdale****STATE****IL****ZIP CODE****62268****Facility Operator(s):**Exemption 6 and Exemption 7C**NAME****CONTACTED**☐ YES ☐ NO**PHONE****MOBILE****ADDRESS****CITY****STATE****ZIP CODE****NAME****CONTACTED**☐ YES ☐ NO**PHONE****MOBILE****ADDRES

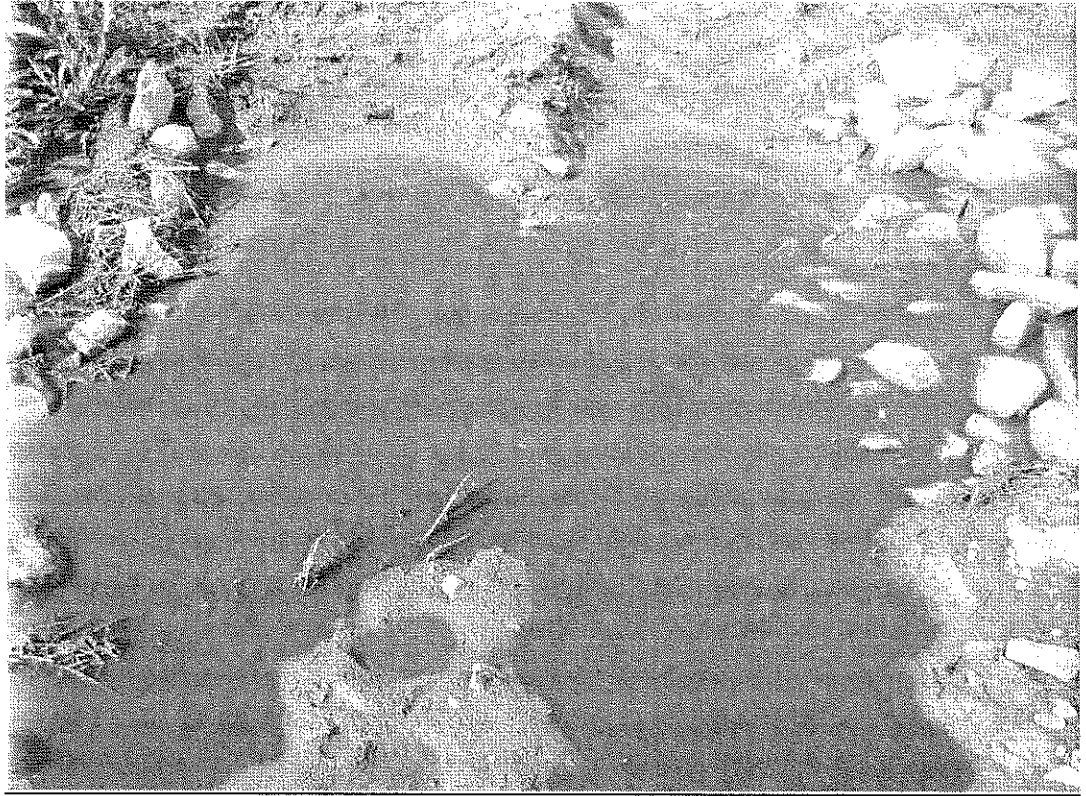
Photo # 001
Date: April 19, 2011
Time: 4:33 p.m.
Taken By: Brian Rodely DWPC/FOS
Facility: FAY-BLA-MAR, Inc.
Location: E end of E-W Field Ditch
Notes: Riprap field crossing shows
dark colored water from
settling of manure from
recent rain event. This is
also sampling location C.

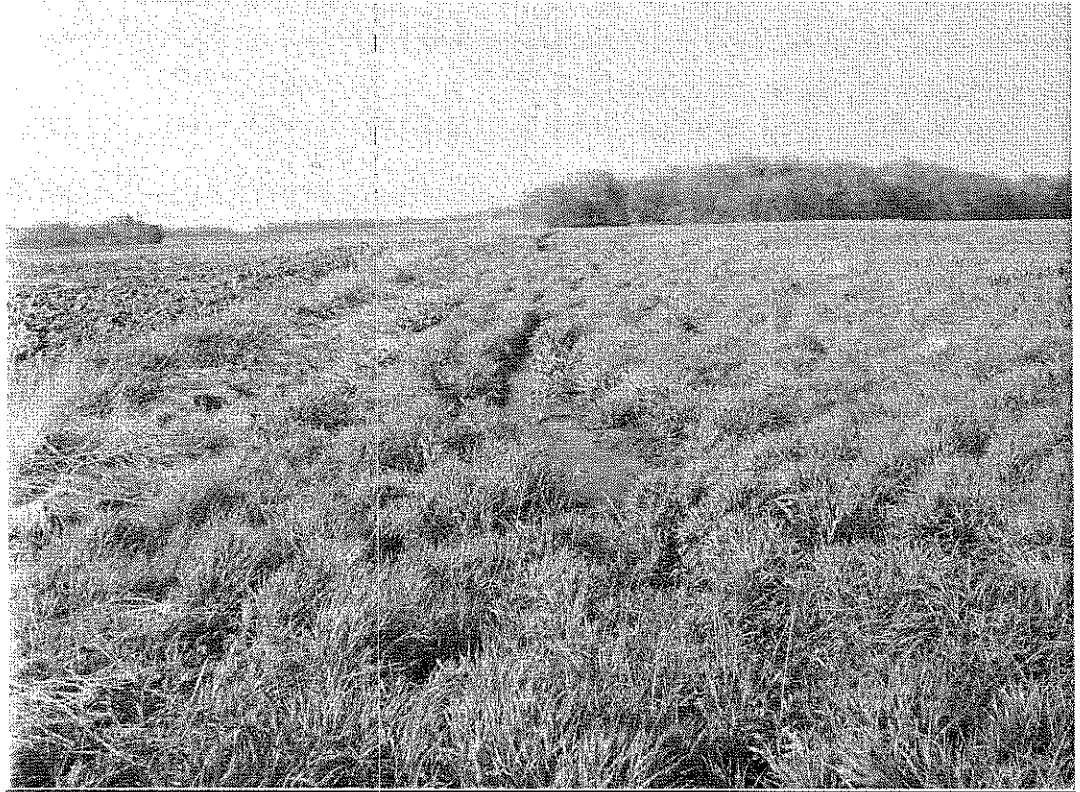
Photo # 003
 Date: April 19, 2011
 Time: 4:38 p.m.
 Facility: Brian Rodely DWPC/FOS
 Location: FAY-BLA-MAR, Inc.
 Notes: S end of N-S Field Ditch
 Manure laden water can be seen in the photo facing north in the north-south ditch where it meets the east-west field ditch. The east-west field ditch is immediately to the right of the camera. Helbig property where land application occurred is to the left (west) of the north/south ditch.

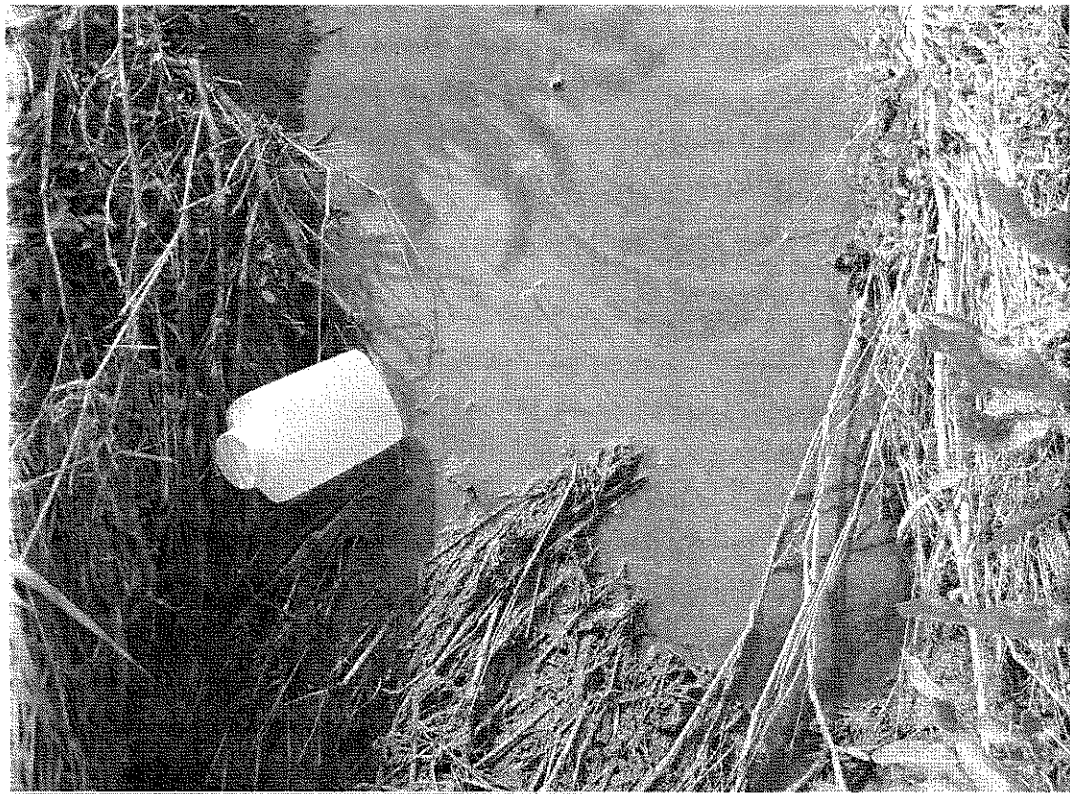
Photo # 005
Date: April 19, 2011
Time: 4:40 p.m.
Taken By: Brian Rodely DWPC/FOS
Facility: FAY-BLA-MAR, Inc.
Location: W end of E-W Field Ditch
Notes: This photo shows a close up of sample location B. Note the dark manure laden water in the field ditch.

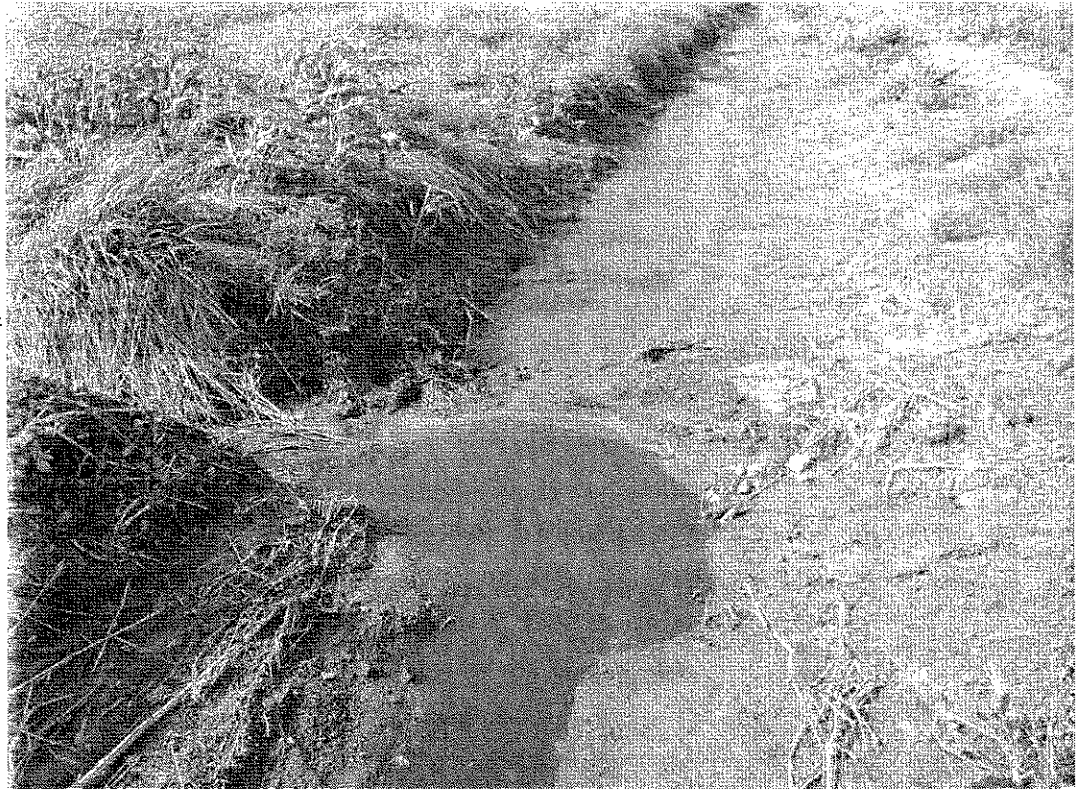
Photo #
Date: 007
Time: April 19, 2011
Taken By: 4:43 p.m.
Facility: Brian Rodely DWPC/FOS
Location: FAY-BLA-MAR, Inc.
Notes: N end of N-S Field Ditch
This photo shows the precipitation runoff that entered the N-S field ditch from the land application site looking north. Note the clear water to the north of the introduction of field runoff from the Helbig site following 1.6 inches of rain.

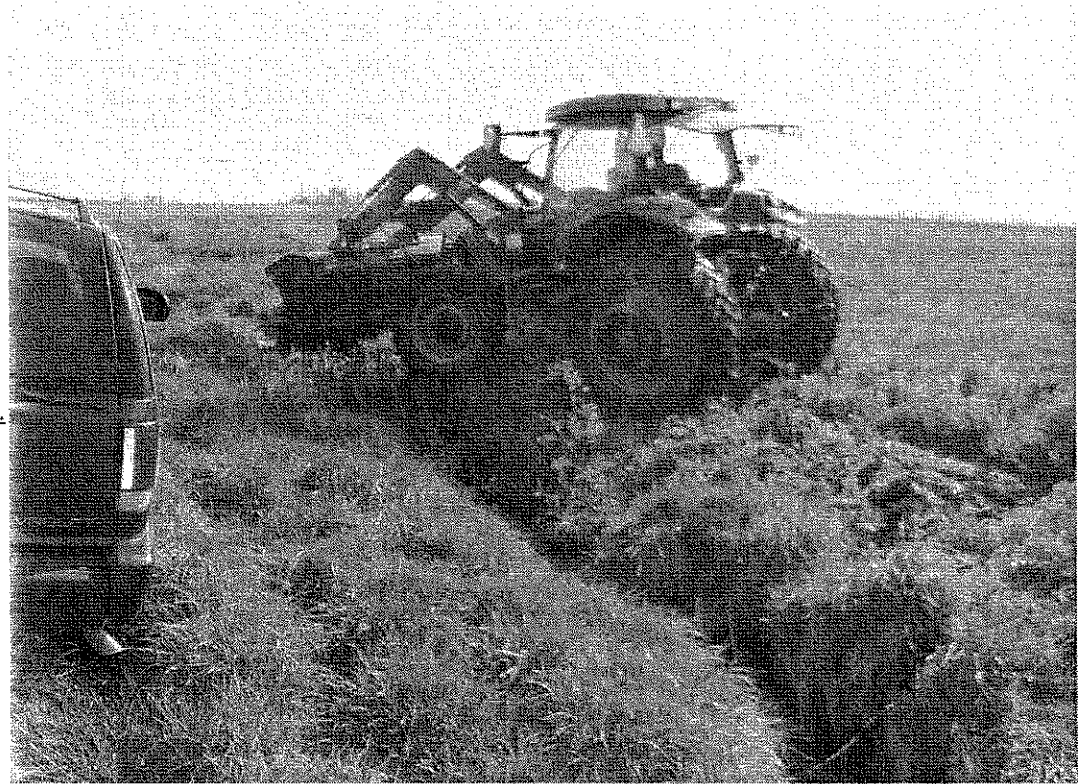
Photo #
Date: 008
Time: April 19, 2011
Taken By: 4:57 p.m.
Facility: Brian Rodely DWPC/FOS
Location: FAY-BLA-MAR, Inc.
Notes: Upstream Unnamed Creek
This photo shows the activity commencing to dam up the clean water upstream of the east-west field ditch in preparation to damming up the downstream area for flushing of the field ditches.

Blake indicated that he would immediately begin flushing and collecting the water from the field ditches and the unnamed creek by damming up the waterway and flushing with clean water. Operations had begun before we left the site at approximately 5:15PM.

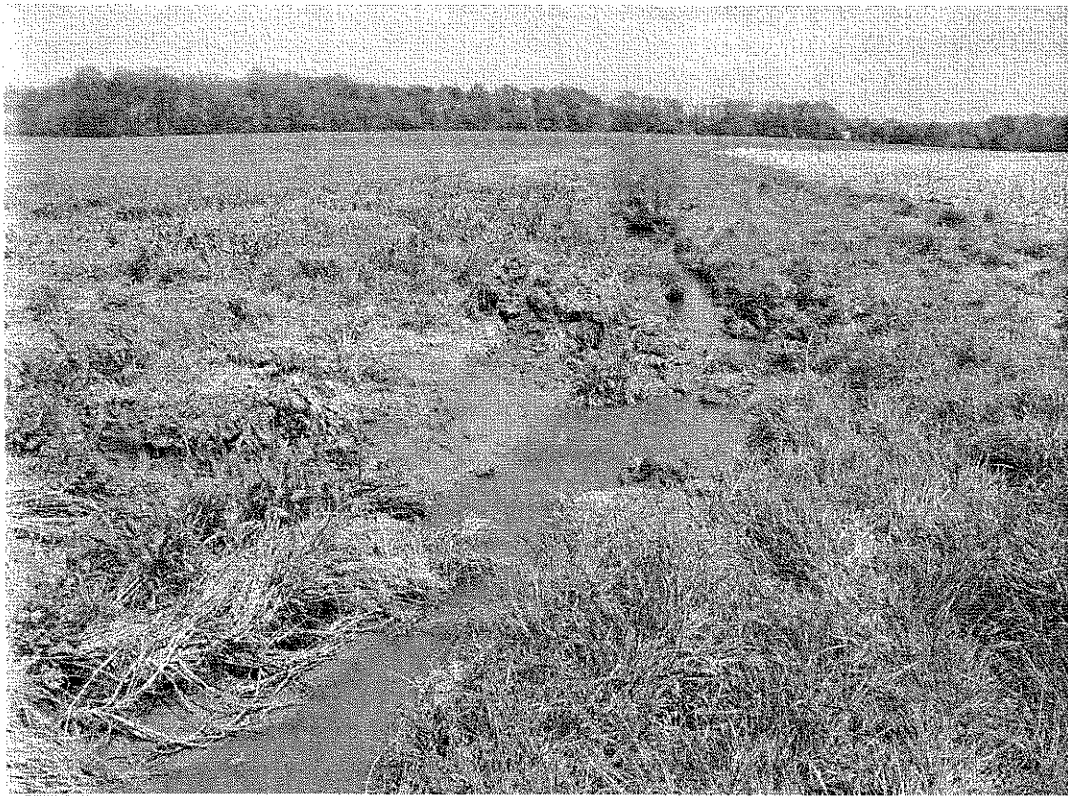
Photo #
Date: 009
Time: April 21, 2011
Taken By: 12:09 p.m.
Facility: Brian Rodely DWPC/FOS
Location: FAY-BLA-MAR, Inc.
Notes: Downstream Creek
This photo shows the removed dam in the unnamed creek downstream the east-west field ditch. Flushing and pumping had occurred throughout the night of 04/19/11 prior to a forecast rain event. Note the clear water in the creek.

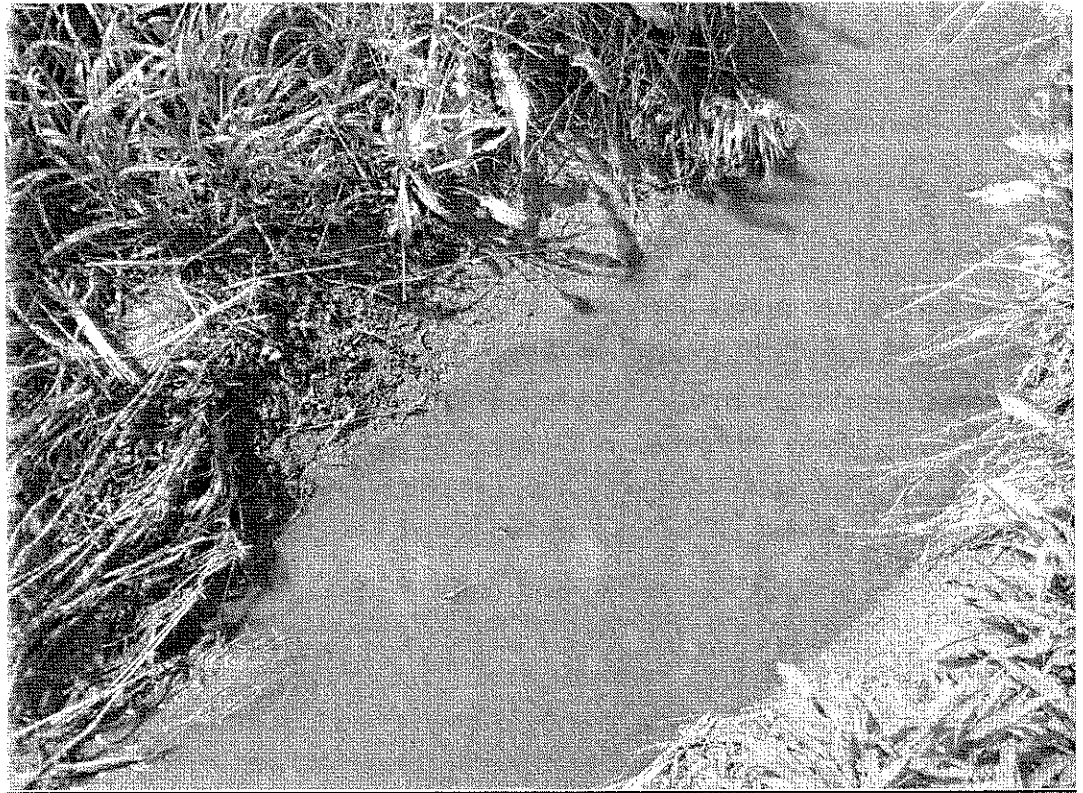
Photo #
Date: 011
Time: April 21, 2011
Taken By: 12:39 p.m.
Facility: Brian Rodely DWPC/FOS
Location: FAY-BLA-MAR, Inc.
Notes: W end of E-W Field Ditch
This photo shows a close
up of sample location B.
Note the clear water in the
field ditch following the
flushing and pumping that
occurred throughout the
night on 04/19/11.
